# Analyzing the Shear Behaviour of Reinforced Concrete Beams Containing Shear Reinforcements at Different Angles

**Abstract:** Shear behavior has been investigated by many researchers for many years on normal concrete specimens. Some researchers are also studying the shear behavior of reinforced concrete beams by using sand, crushed stones, and steel as coarse aggregate to counter the effect of shear. The aim of this study to investigate the shear behavior of reinforced concrete beams by providing shear reinforcement at different angles. Shear behavior of reinforced concrete (RC) elements can be improved with an adequate amount of steel. The RC element is reinforced by providing stirrups at different angles. In order to study shear behavior on reinforced concrete beams shear strips has been provided as shear reinforcement at the angles of 90,30,45 and 60. Experimental investigation showed that the beams having shear strips at an angle of 45 are more reliable than reinforced concrete beam having stirrups at other angles.

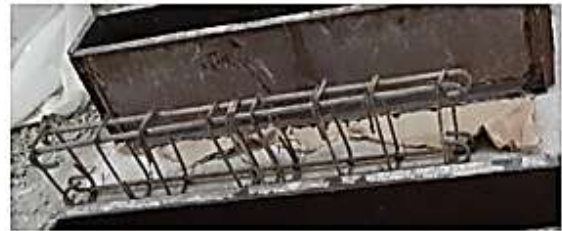
Figure 1 Schematic Diagram of 90 Degree Stirrups

Schematic Diagram of Beam 1 (90° Angle)

Steel reinforcement at the 90° Angle

For the 90-degree steel fixing bar size #4 and bar size #3 are used. Bar size #4 is used as main reinforced bars and bar size #3 is used for stirrups as shown in Figure 1. The no of stirrups used for 90 beams are 9. The total net weight of steel for the 90-degree beam is 17 to 20kg approximately. During testing, the beam was in UTM machine and load is applied. The deflection behavior, loading capacity and the appearance of cracks on the beam are observed during the experimental investigation.

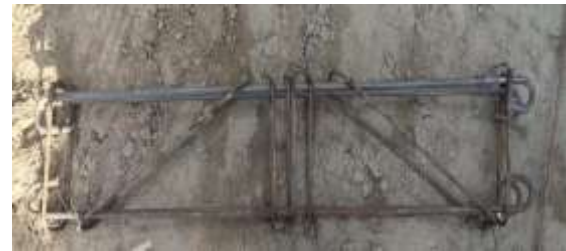
Figure 2 Schematic Diagram of 30 Degree Stirrups

Schematic Diagram of Beam 2 (30° Angle)

Steel reinforcement at 30° Angle

For the 30-degree steel fixing bar size #4 and bar size #3 are used. Bar size #4 is used as main reinforced bars and bar size #3 is used for stirrups as seen in figure 2. The no of stirrups used for 30degree beams are 7. The total net weight of steel for the 30-degree beam is 15 to 18kg approximately.

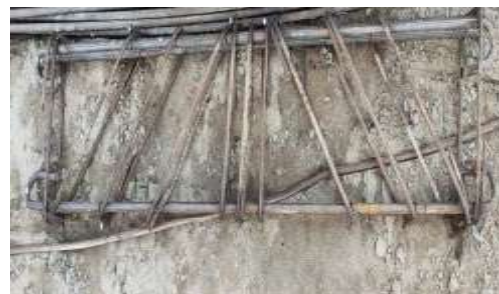
Figure 3 Schematic Diagram of 45 Degree Stirrups

Schematic Diagram of Beam 3 (45° Angle)

Steel reinforcement at 45° Angle

For the 45-degree steel fixing bar size #4 and bar size #3 are used. Bar size #4 is used as main reinforced bars and bar size #3 is used for stirrups. The no of stirrups used for 45degree beams are 11 in Figure 3. The total net weight of steel for the 45-degree beam is 20 to 22kg approximately.

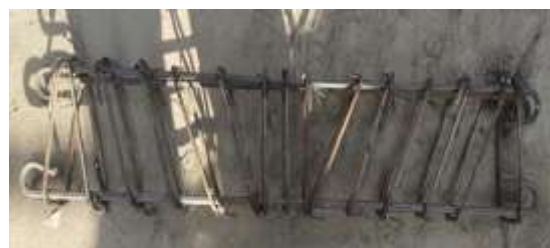
Figure 4 Schematic Diagram of 60 Degree Stirrups

Schematic Diagram of Beam 4 (60° Angle)

Steel reinforcement at 60° Angle

For the 60-degree steel fixing bar size #4 and bar size #3 are used. Bar size #4 is used as main reinforced bars and bar size #3 is used for stirrups. The no of stirrups used for 60degree beams are 17 in Figure 4. The total net weight of steel for the 60-degree beam is 22 to 25kg approximately.

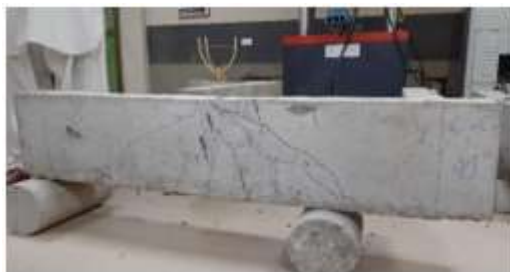
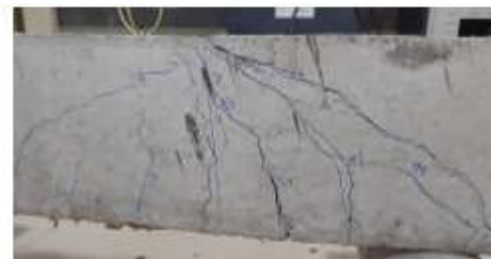
Figure 5 Cracking Behaviour of Beam having 90 Degree Stirrups

Cracking of Beam at 90° Angle

Flexural Cracks of Beam at 90° Angle

This determines the member size and the reinforcement needed to achieve the required moment resistance. Restrictions are applied to flexural reinforcement to ensure the structure fails gradually rather than suddenly. However, the shear is the only failure in concrete that is frequently sudden and brittle. Therefore, the shear strength must be higher than flexural strength in the shear design of RC members. For the purpose of calculation & result Beam shows the shear flexure failure at the load of 119KN as mentioned in Table 1. Ten cracks appeared on the beam as shown in Figure- 5.

The failure modes of all designed beams with shear reinforcement upon testing under UTM are shown in Figure 5,7,9 and 11. It can be seen in these figures that all beams showed flexural shear failure without showing any anchorage failure. Flexural shear failure occurs in these beams through three main stages: At first, the crack begins to form at the bottom of the beam due to flexural tensile stress. In second stage, the crack bends in a diagonal direction as it travels towards the upper end of the beam along with continuation to propagate in length and widen in breadth. And, finally, when the diagonal tensile stress exceeds the tensile strength of the concrete, the RC element fails by crushing or by shear.

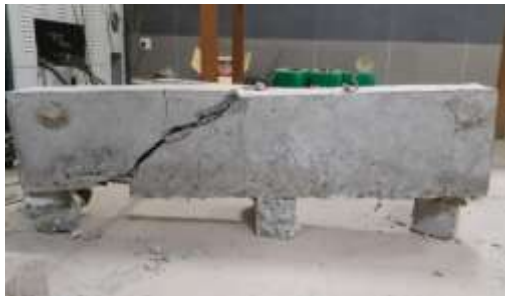
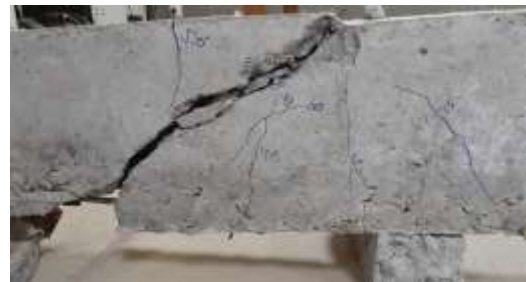
**Figure 7 Cracking Pattern for the beam at 30° angle**

*Cracking of Beam at 30° Angle*

*Flexure Cracking of Beam at 30° Angle*

Figure 6 present the stress strain curve of the beam # 1 when it is subjected to tensile loading in the UTM. It can be clearly seen in the fig-5 that the beam starts to show the phenomenon of shear cracking. The initial crack in the beam, as indicated on the Y-axis of Fig-6, appeared at a load of 53 kN with a strain of less than 0.55% on the X-axis. The second crack emerged under a UTM compressive load of 57 kN, with the strain percentage exceeding 3%. The third crack was observed at an applied load of 62 kN, with the strain surpassing 6%. The beam was giving cracks gradually as the compressive load applied by the UTM was increasing. The process of cracking went up to more than 5 minutes. After that beam shows its last crack at the compressive load of 119KN and after the beam shows the flexural shear failure and fails. Applying the compressive load by UTM, beam shows the shear flexure failure at the load of 81KN. Nine cracks appeared on the beam in Figure 7.

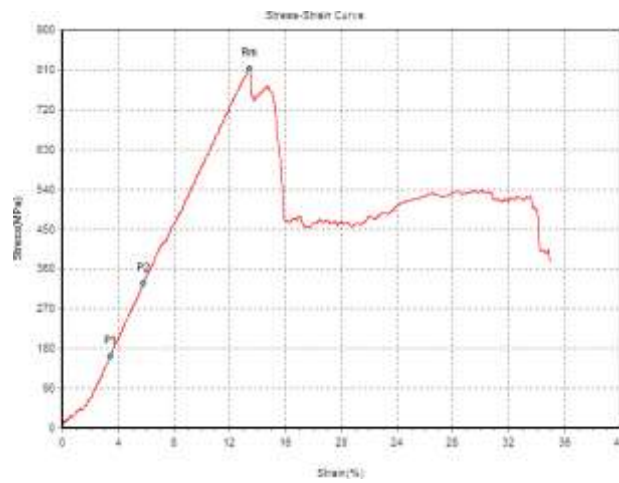
**Figure 8 Stress Strain Behaviour of Beam having 30 Degree Stirrups**

The stress-strain curve of beam # 2 under UTM loading is presented in figure-8. During the test under the UTM, we clearly observed the beam starting to show signs of shear cracking. The first crack appeared at 40 kN with a strain of less than 6.2% on the X-axis. As the compressive load increased to 45 kN, a second crack formed, with the strain exceeding 8%. A third crack was visible at 47 kN, with the strain going beyond 8.2%. The cracks developed gradually as the UTM applied more compressive load. This process continued for over 5-7 minutes. Finally, at a compressive load of 81 kN, the beam showed its last crack and then failed due to flexural shear.

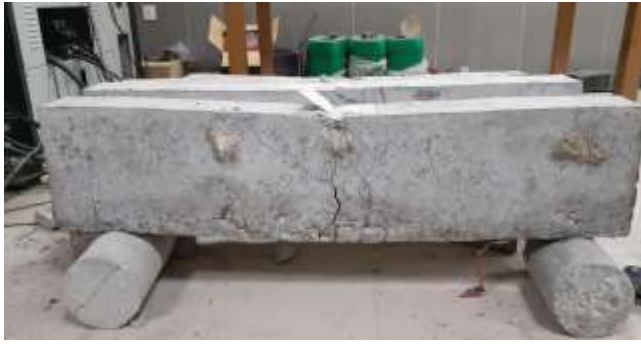
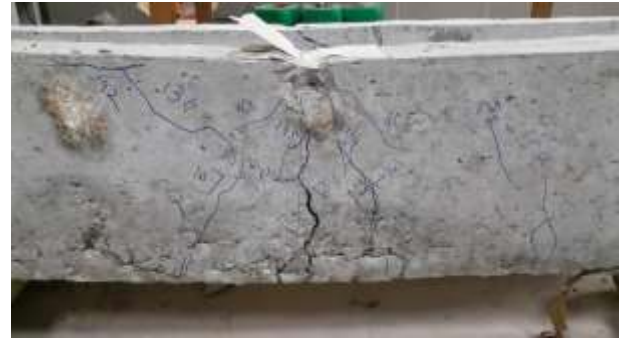
**Figure 11 Cracking Pattern for the beam at 60° angle**

*Cracking of Beam at 60° Angle*

*Flexural Cracking of Beam at 60° Angle*

Applying the compressive load by UTM, beam shows the shear flexure failure at the load of 147KN in Table 1. Fourteen cracks appeared on the beam shown in Figure 11. From the Figure 12, it has been observed that the beam whose shear reinforcement is provided at the angle of 60° was laid under the UTM for testing purpose. During the test under the UTM it has been clearly
