# Lessons learnt during experimental study of Bond Slip behavior of GFRP bars MS rebars

**Abstract.** Bond strength of concrete-rebar composite directly influences load carrying capacity of reinforced concrete structures. It becomes more crucial when the structure is exposed to harsh environmental conditions including elevated temperatures, chemical, or mechanical loading. A research program was designed to evaluate the bond slip behavior of mild steel rebars and glass fiber reinforced polymer bars GFRP when subjected to above three conditions. In this investigation a total of 18 specimens were prepared. Six specimens, three of both categories were directly subjected to pullout test. A further six specimens, three of each category were first exposed to acidic solution (HNO<sub>3</sub> solution) of 2 pH then subjected to pullout test. Then six specimens, three of each category were first exposed to elevated temperature of 800 °C in an electric furnace then subjected to pullout test. However in this paper discusses pull out test of bars only. This study concluded that GFRP bars lost their integrity at high temperature due to resin damage. Further while performing pullout tests ends

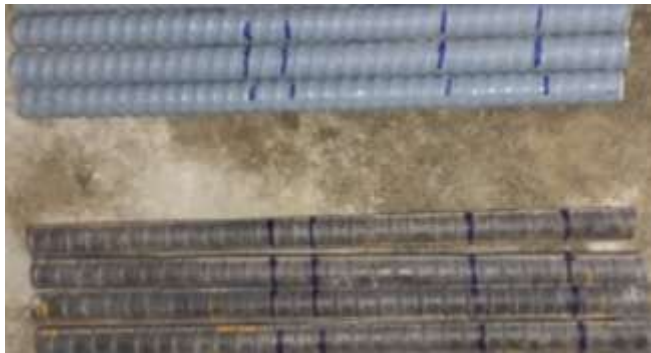
Figure 1 Ms and GFRP rebars used in the investigation.

15 in (375 mm) long steel bars of 0.75 in (19 mm) diameter were used in the process with herringbone (round) shape rings on them. This design helps to enhance the bond between the steel bars and the surrounding concrete, providing improved tensile strength and reinforcing the concrete against cracking and structural failure. The primary purpose of using herringbone-shaped steel bars in concrete structures is to increase the load-carrying capacity of the concrete and improve its overall mechanical properties. The bars are typically placed in specific locations where tensile forces are expected to occur, such as in beams, columns, slabs, and other critical areas of the structure.

15 in (375 mm) GFRP bars of 0.75 in (19 mm) diameter were used in the process. The spiral shape GFRP bars are typically used as an alternative to conventional steel bars in reinforced concrete structures. They come in the form of helical or spiral-shaped bars, providing axial reinforcement to concrete members like beams, columns, and piles. The helical shape offers increased surface area for bonding with the surrounding concrete, ensuring good load transfer and enhancing the structural performance of the concrete element. Both steel and GFRP bars are shown in Figure 1.

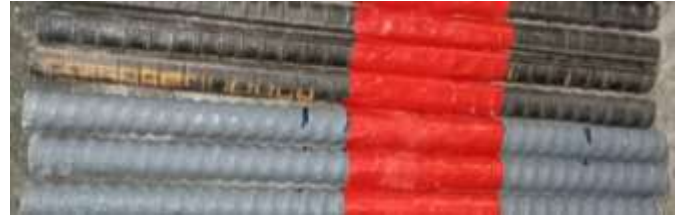
A development length (within 6in cube) equivalent to three times the diameter of the bars that is equal to 2.25 in (56.25 mm) is provided in the concrete cube while the remaining 3.75 in (93.75 mm) of the bar was covered with duct tape. Both steel and GFRP bars are shown in Figure 2.

Figure 2 Development Length

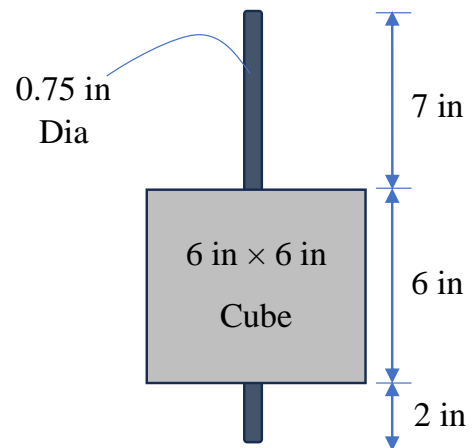
Figure 3. Specimen Dimensions.

All bars were placed 2 in (50 mm) outside from the bottom of the cube and 7 in (175 mm) outside from the top of the cube ensuring proper 2.25in (56.25mm) embedment. Then the concrete was poured into the molds in 3 layers with the proper use of a vibrator for adequate compaction. After 48 hours specimens were de-molded, then the specimens were cured for 28 days. Figure 3 illustrates the dimensions of the specimen, and figure 4 explains the arrangement of mould and rebars.

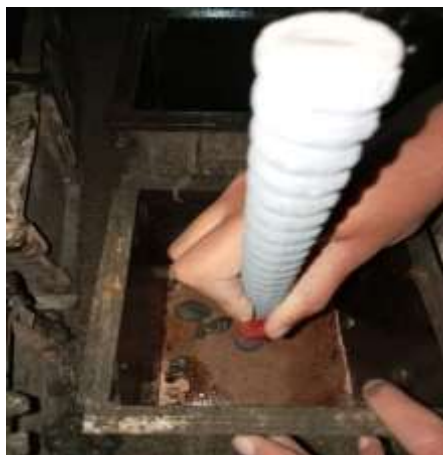
Figure 4. Rebar being placed in the mold.

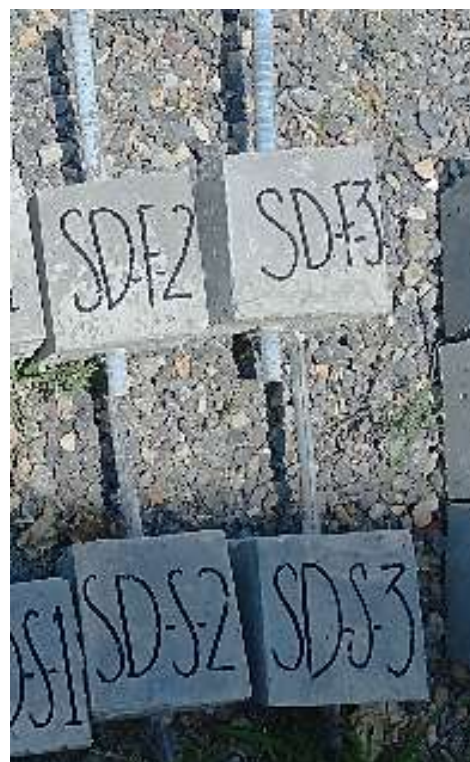
Figure 6 Specimens ready for testing

For the identification the specimens were named. The first alphabet in the nomenclature (S) denotes ‘Specimen’. The second alphabet (A, F, D, or C) denotes ‘Type of Test’; {“A” stands for Acid Exposure, “F” stands for Fire Exposure, “D” stands for Direct Pullout, or “C” stands for Compressive Strength}. The third alphabet (F or S) denotes ‘Type of Bar’; {“F” stands for FRP, or “S” stands for Steel}. Identification name was written on each specimen as shown in figure 6. Detail of specimens is shown in Table 2.

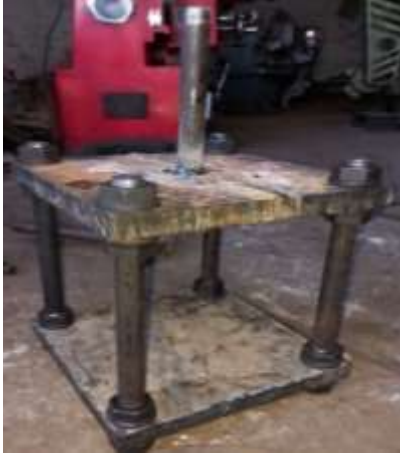
Assembly/Frame of iron was prepared for pullout test. This assembly consists of two 1-in (25 mm) thick 10 in × 10 in (250mm × 250mm) solid iron plates at the top and bottom. The upper plate has four 0.75 in (19 mm) diameter holes at the corners and one 1 in (25 mm) diameter hole in the center. While the lower plate has one 0.75 in (19 mm) diameter bar 6 in (150 mm) long connected at the center through welding. Four 0.75 in (19 mm) iron rods of 16 in (400 mm) length bolted from both

**Figure 7** Assembly for pull-out test

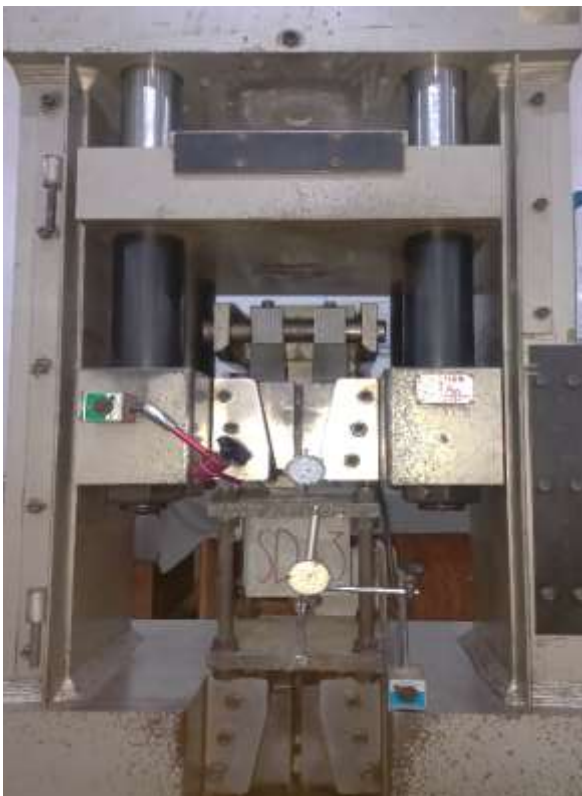
**Figure 8** Pull Out test assembly fitted in UTM Machine.

sides to support plates. Fig 3.9 illustrates the dimensions of assembly for the pull-out test. Pull-out test was performed in the UTM machine as illustrated in Figure 8. Dial gauges were fixed at suitable locations to record the slip of the bars.

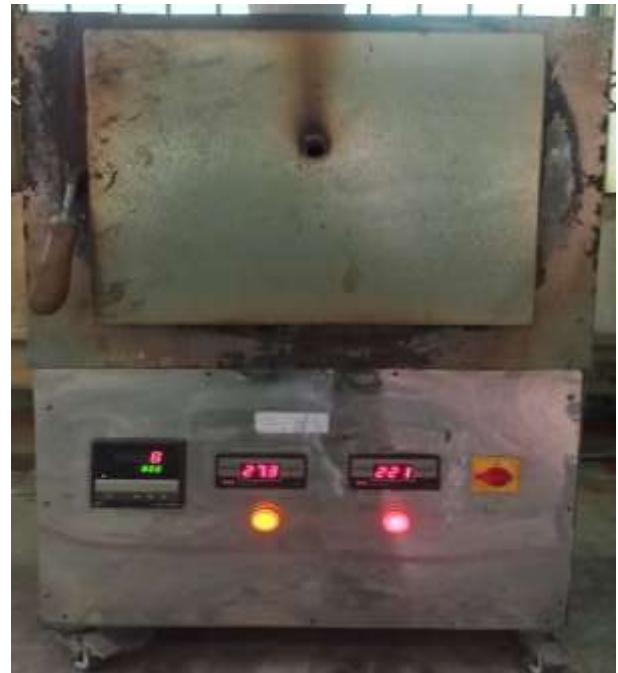
An electric furnace as shown in figure 9 was used to expose specimens to elevated temperatures. The heating capacity of the furnace was 900 °C. It can accommodate

three specimens at a time. It took 1 hour to attain the desired temperature of 800 °C.

**Figure 9** Electric Furnace

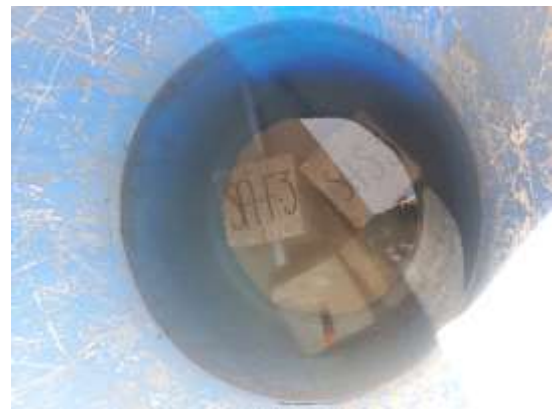
A circular plastic container shown in figure 10. was used for exposure of specimen to the acidic solution. Nitric acid (HNO<sub>3</sub>) of 65% purity was used. The pH of the water was maintained at 2 and checked using electric pH meter.

**Figure 10.** Plastic container for acid exposure of the specimens.

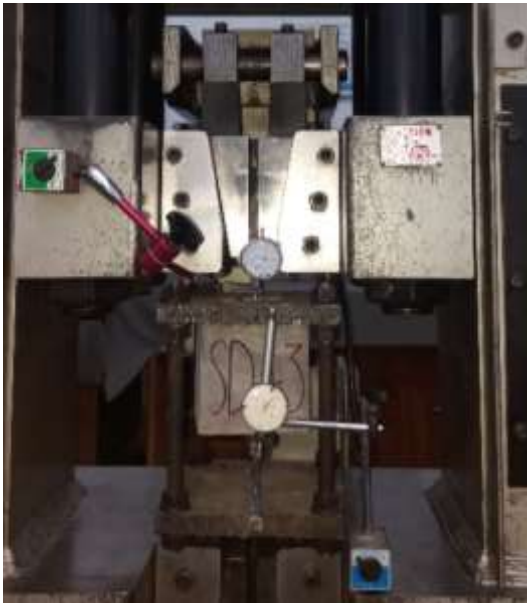
Figure 11 Specimen SDS3 Before Pull-out Test

Rebars embedded within a concrete cube were pulled out by applying a tension force at a static loading rate and with a confined test setup. The applied force values and corresponding relative displacement between rebar and

concrete known as bond-slip are continuously measured and recorded by the UTM Machine and the deflection gauges. GFRP specimen SDS-1, 2 and 3 and SDF-1, 2 and 3 were tested after 28 days. These specimens were not subjected to any external exposure. Figure 11 and 12 illustrates specimens before testing and after testing respectively.

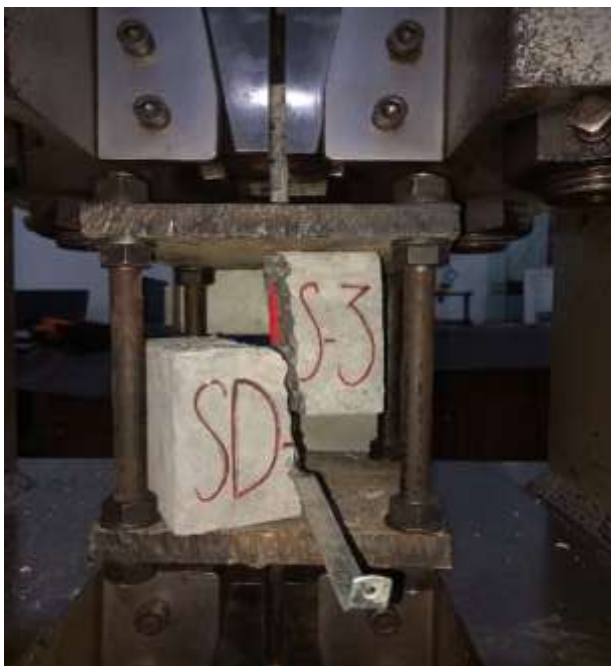
Figure 12 Specimen SDS3 after Pull-out Test

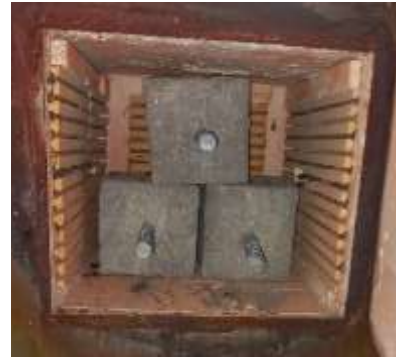
Figure 13 Specimens before temperature exposure

Samples numbers SF-S-1, 2, 3 and SF-F-1, 2, 3 were exposed to an elevated temperature in an Electric Furnace

with a capacity to hold three specimens at a Time. The samples were exposed to high temperatures for About 2 hours and the readings were properly noted to obtain the time versus temperature curve. The Furnace took about one hour to reach the required temperature of 800 °C and then the same temperature is maintained for an hour.

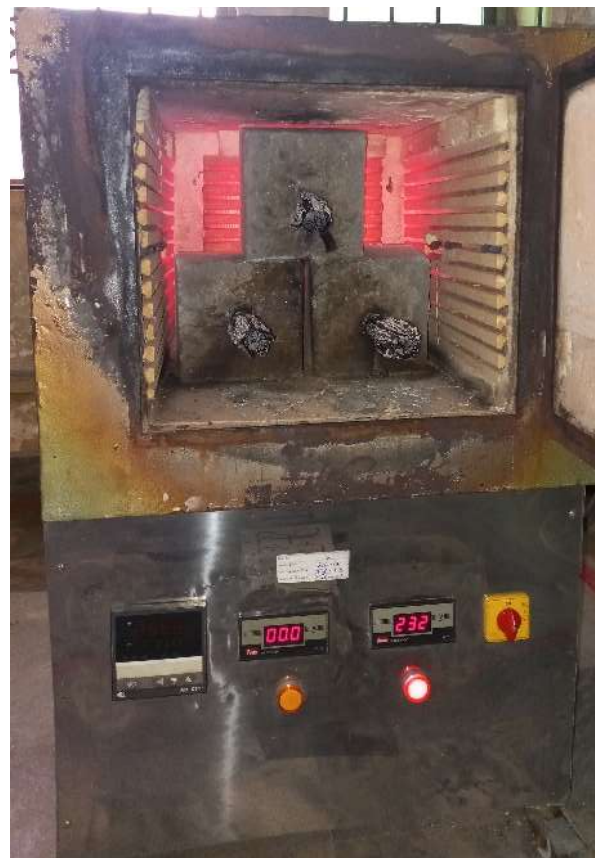
Figure 14 Specimens after temperature exposure

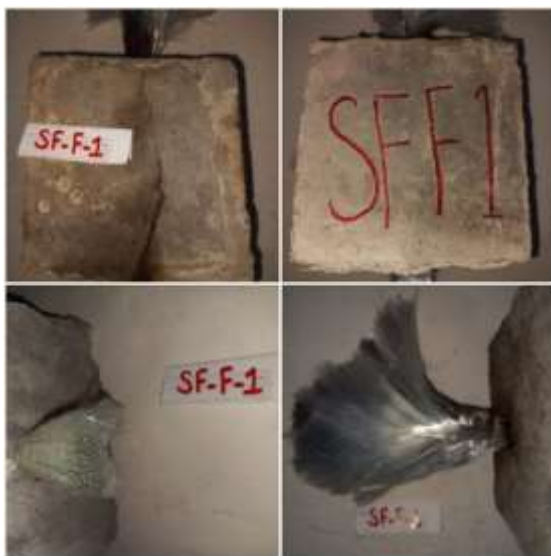
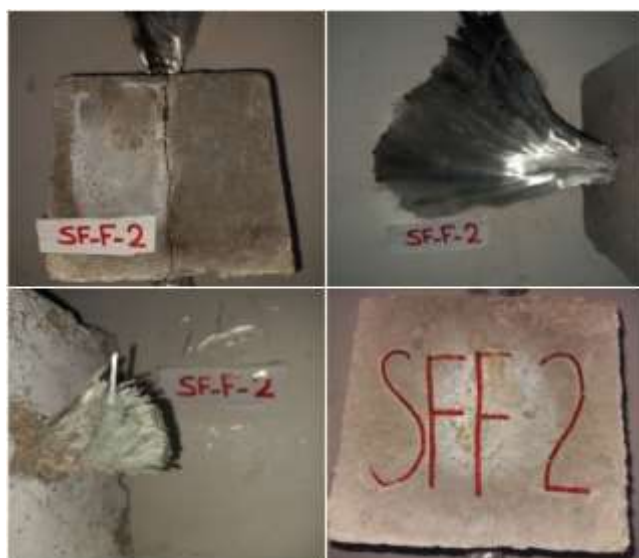
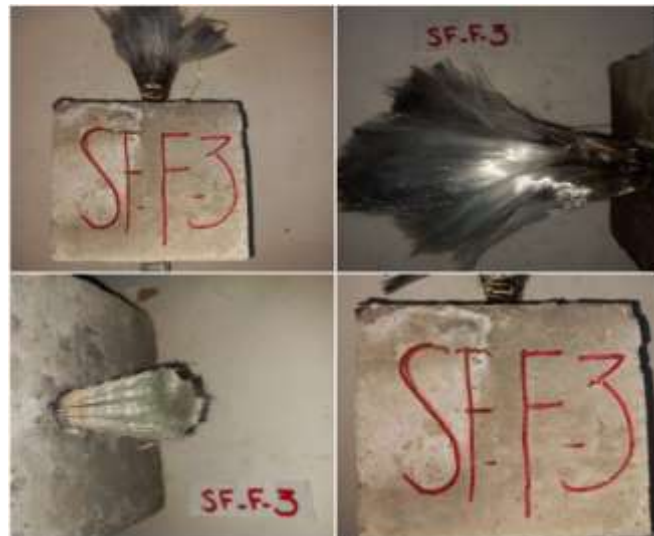
**Figure 15 Specimen SF-F-1 after exposure.**

**Figure 16 Specimen SF-F-2 after exposure.**

Cracks appeared on the surface of concrete and along rebar at few locations. Resin of GFRP bar was burnt and the fibres were separated leaving brush like structure.

**Figure 17 Specimen SF-F-3 after exposure.**

Specimens with GFRP bars and subjected to elevated temperature are shown in figures 15, 16 and 17.

- I. GFRP exposure to high temperatures up to 800 °C leads to the deterioration of the resin and GFRP bars turns into the raw fibers, leaving these bars ineffective and compromising the structural integrity.

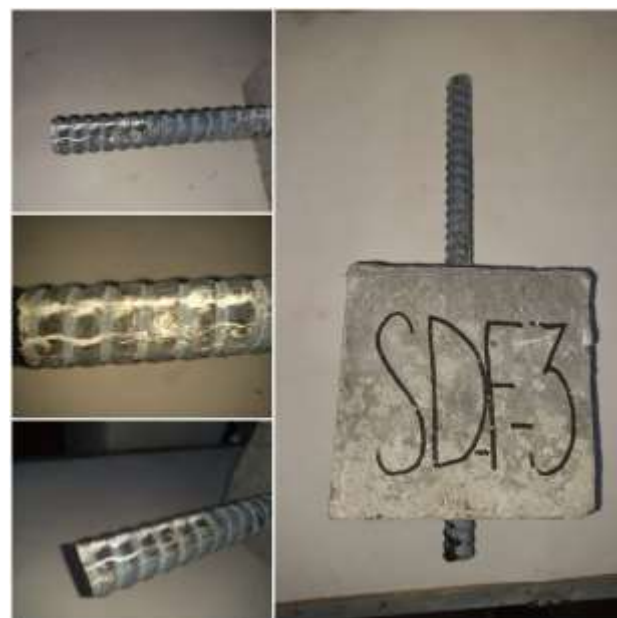
Direct Pullout test was performed on SD-S-1, 2 and 3 and SD-F-1, 2, 3. As shown in figure 18 due to limitation of the equipment it was not possible to pull out GFRP bars to its full capacity. It was due to the reason that the bars were crushed in the jaws of UTM.

**Figure 18 Specimen SD-F-3 after Pull out test.**

- II. GFRP is a very delicate material as compared to steel and can be compressed easily with UTM jaw tightening, leading to the unreliable results of pullout test. A special assembly is required to perform pull out test on GFRP bars.
- III. The bond slip behavior analyzed by the deformation gauges shows higher deformation in the free end bond side slip and smaller deformation in the loaded end bond slip.

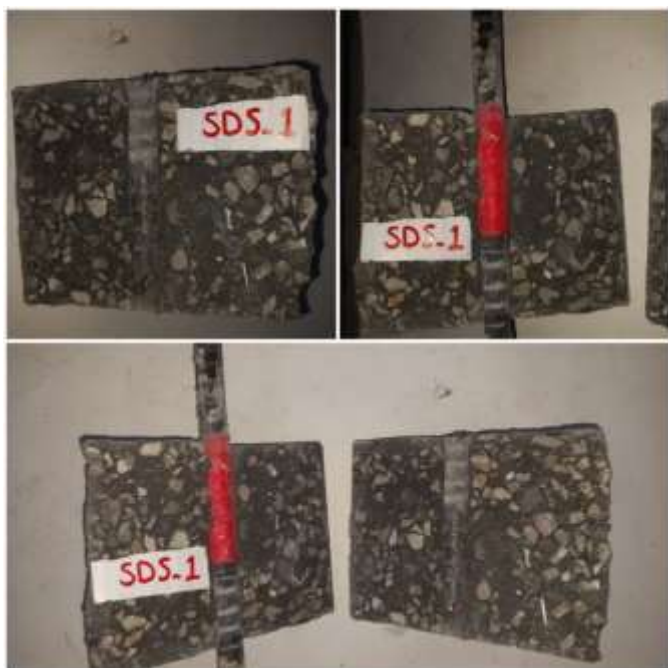
Figure 19 . SD-S-1 tested specimen.

Three specimens SD-S-1, SD-S-2, and SD-S-3 with MS rebars were subjected to direct pull-out test. Results of these are shown and discussed below individually. The

SD-S-1 specimens after testing are shown in the figure below.

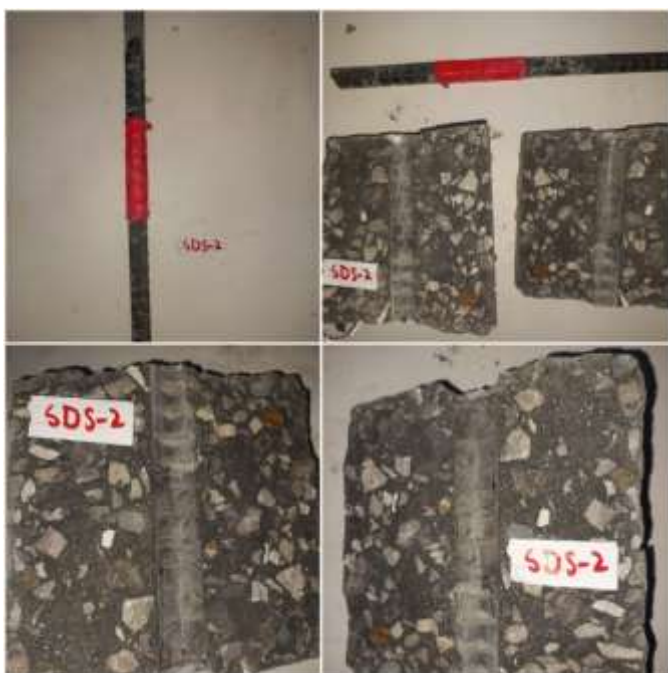
Figure 20 SD-S-2 tested specimen.

The SD-S-2 specimens after testing are shown in the figure 20 below.

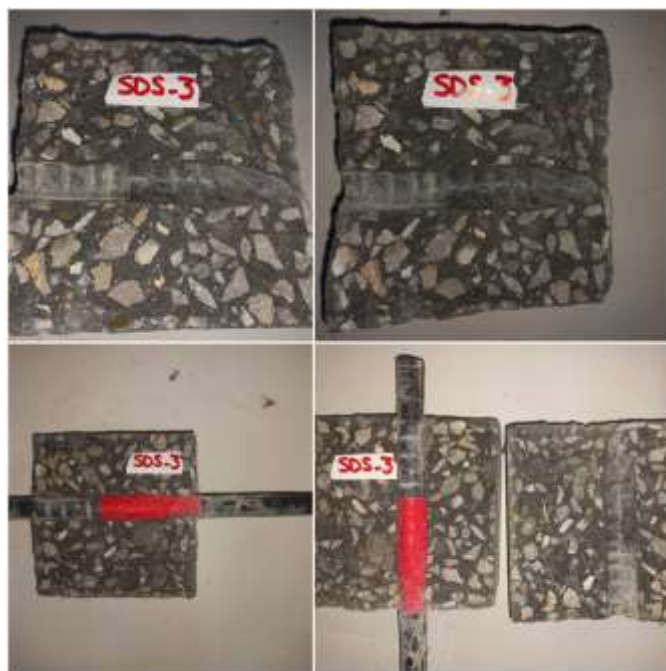
The SD-S-3 specimens after testing are shown in the figure 21 below. This specimen was broken from the center parallel to rebar. It was divided into two pieces and rebar remained attached with one piece

Figure 21 SD-S-3 tested specimen.

Specimens	Diameter of Bars (mm)	Embedment Length (mm)	Concrete Age (Days)	Maximum Bond Stress (MPa)	Max. loaded End bar slip (mm)	Max. free End bar slip (mm)
SD-S-1	19.05	57.15	28	7.52	6.59	4.95
SD-S-2	19.05	57.15	28	8.6	9.65	3.31
SD-S-3	19.05	57.15	28	6.45	7.7	6.18
